**West Hill Pond**

**New Hartford, CT**

**Aquatic Vegetation Survey  
Water Chemistry**

**2022**

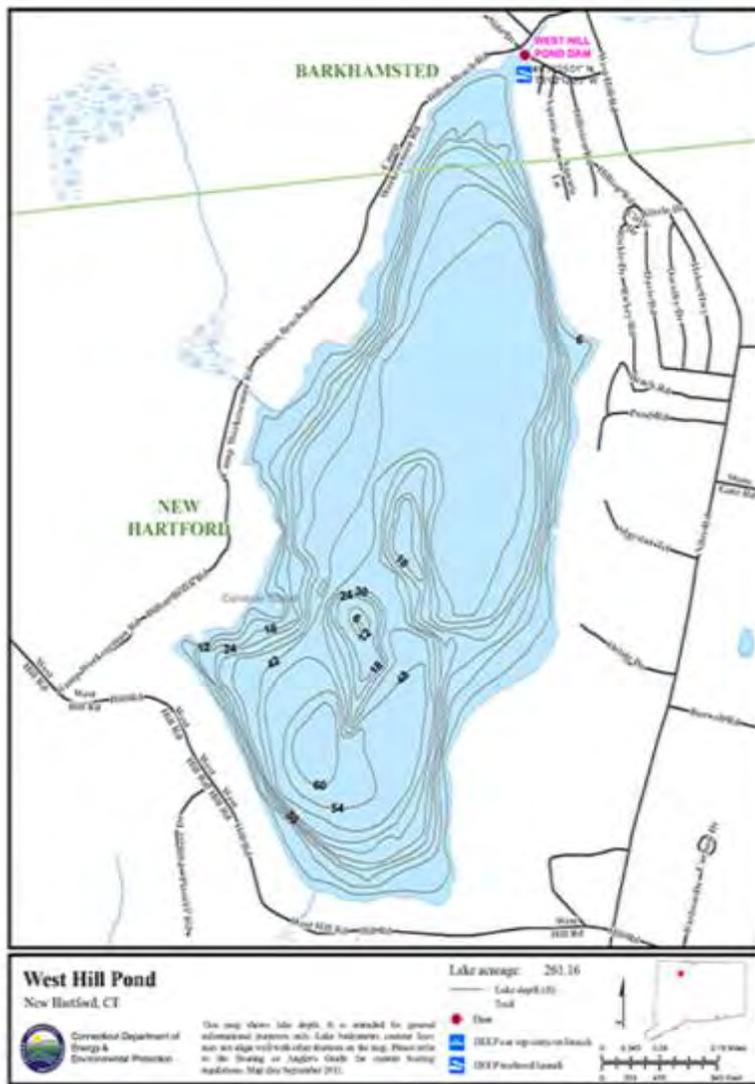
**Figure 2.** Topographic map of West Hill Pond (CT DEEP).

has large areas of rocky substrate that combined with its nutrient poor water and deep areas offer natural limitations to aquatic plant growth (Figure 2). Previous work on West Hill Pond dates to the 1940's when the State Board of Fisheries and Game (1942) described the lake as having exceptional transparency and “extensive submerged weeds below the wave action zone” (no specifics). Another publication by the State Board of Fisheries and Game (1959) mentions West Hill Pond having a sand, gravel and rubble bottom, very clear water, and scarce submerged vegetation (no specifics). The change from a lot to a little submersed vegetation from 1949 to 1952

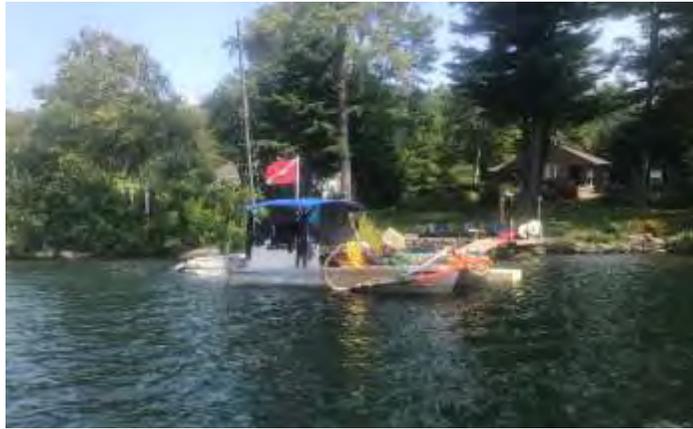
**Figure 3.** Diver assisted suction harvesting apparatus used during the CAES IAPP 2022 survey.

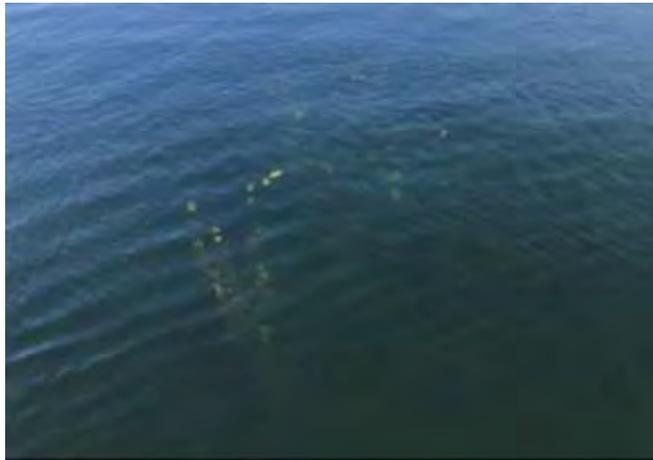
**Figure 5.** Typical low abundance patch of ribbon-leaf pondweed in West Hill Pond.

Diver assisted suction harvesting is currently being performed to manage some of the sparse population of aquatic vegetation, particularly ribbon-leaf pondweed (Figure 5). Although removal of this vegetation when it becomes problematic in swim areas etc. creates a short-term benefit, long term benefits are likely minimal, and a reduction of aquatic habitat is possible. Perennial plants such as ribbon-leaf pondweed have root systems. Root removal is difficult in the best of circumstances

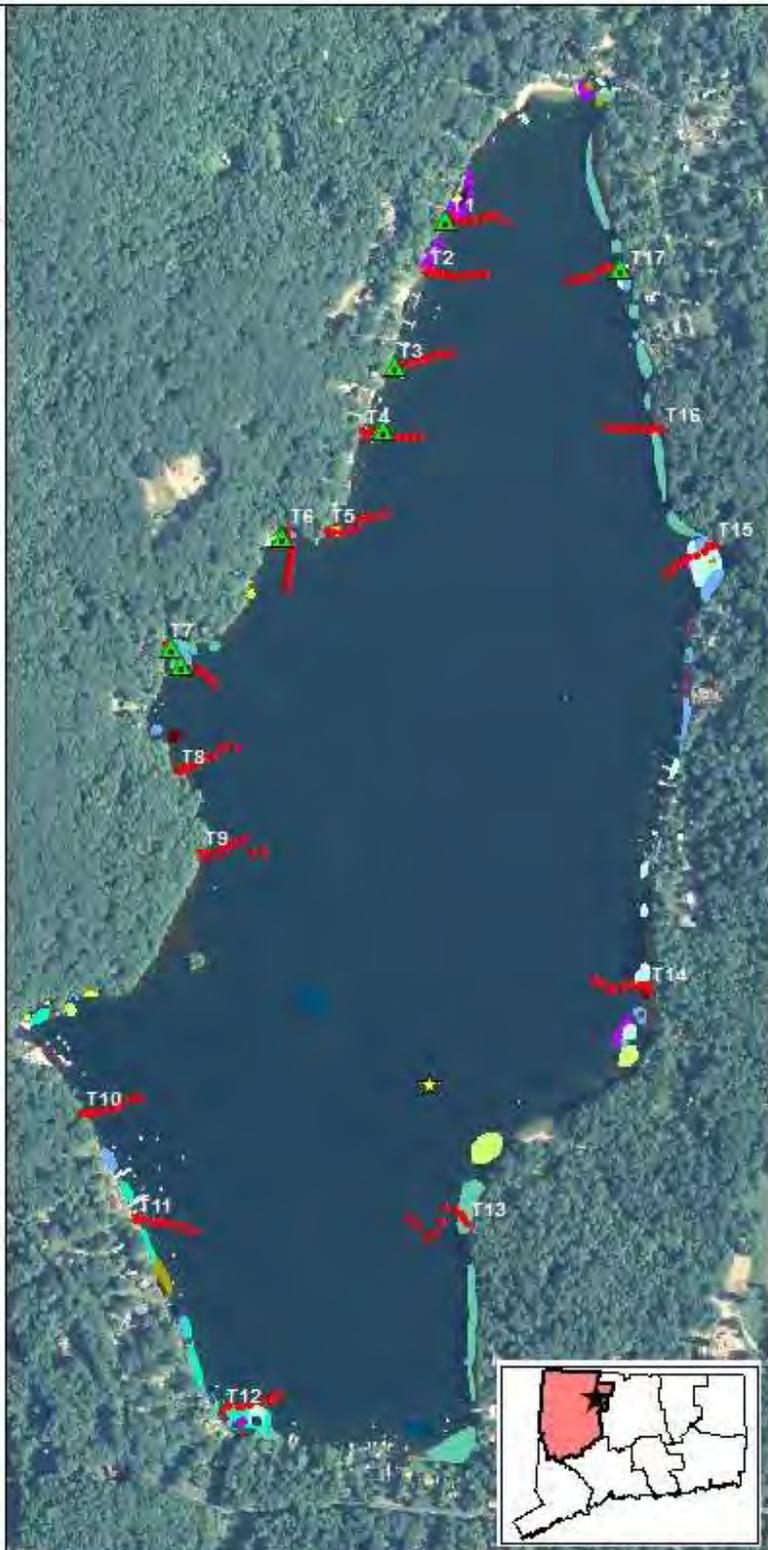
## West Hill Pond New Hartford, CT 245 acres

Surveyed September 12-14, 2012  
by Mark June-Wells and Brian Hart  
Invasive Aquatic Plant Program
